# R/C Frame Structures with Beams Wrapped by Aramid Fiber Reinforced Polymer Sheets

Wael A. Zatar<sup>1</sup> and Hiroshi Mutsuyoshi<sup>2</sup>

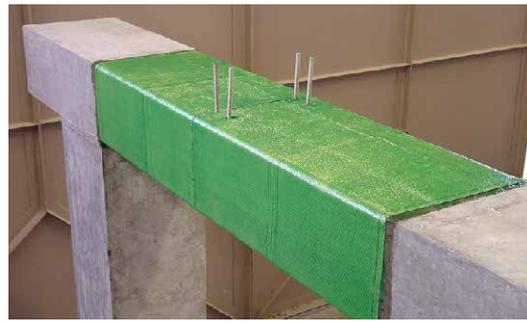
b) Specimen S-4 (fully wrapped)

Fig. 2 Wrapping the RC beams of specimens S-3 and S-4 with Aramid Fiber Reinforced Polymers (AFRP) (specimen S-3 is U-wrapped with anchorage and specimen S-4 is fully wrapped).

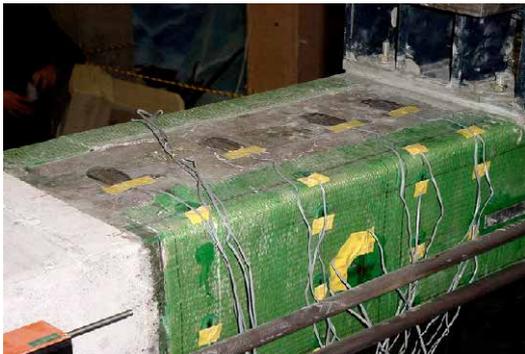
c) Strain measuring of beam of specimen S-3

The tensile strains were recorded from the readings of the strain gauges during every loading step at different locations of the AFRP sheets, where the locations of the strain gauges are shown in Fig. 2c. A plot of the tensile strains of the AFRP sheets along the beam length is shown in Fig. 10. The horizontal axis of the plot represents the distance from the center of the RC beam, and a zero distance is where the centerline of the beam is located. Despite the large data files, selected AFRP tensile sheet strains were plotted at displacements of  $\pm 2\delta_y^{nominal}$  ( $\pm 18$  mm), and  $\pm 3\delta_y^{nominal}$  ( $\pm 27$  mm). The maximum tensile strains of the AFRP sheets were recorded at displacements of +575 mm and -575 mm from the center of the beam (at the right and left ends of the RC beam). A strain of 4200 micron was recorded when the displacement of the actuator was equal to +27 mm (in the push direction). The maximum tensile strain of the AFRP sheet was equal to 6100 micron, which was recorded when the displacement of the actuator was equal to -27 mm.

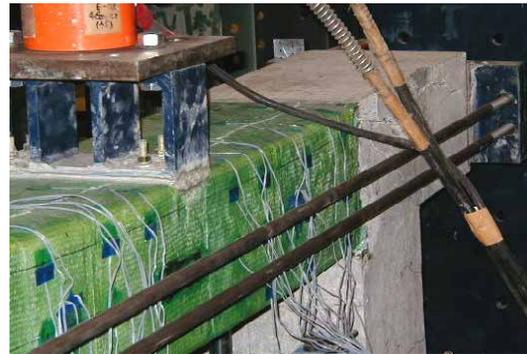
d) Strain measuring of beam of specimen S-4

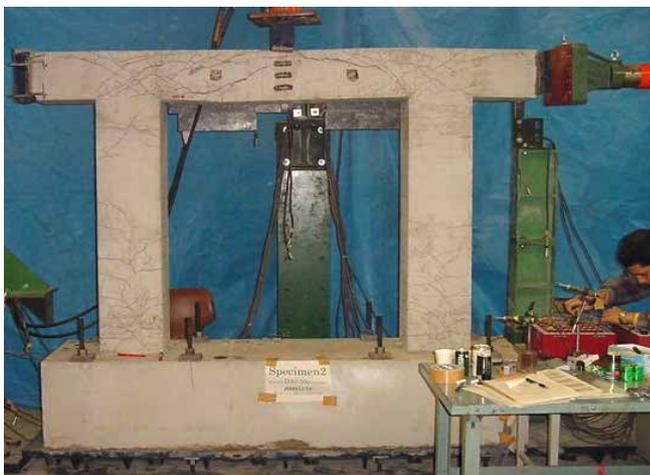
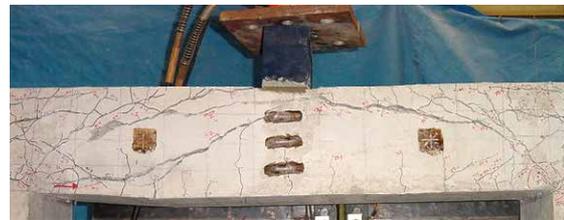
a) Specimen S-2

b) Beam

Fig. 7 Damage to specimen S-2 at the end of the experiment (shear reinforcement ratio = 0.10%).

During the push loading, the adjacent right beam-to-column connection was an opening moment connection while the left one was a closing moment connection. As anticipated, failure of specimen S-2 occurred in the left side of the RC beam during the push

It is noteworthy to point out that specimen S-2 displayed a higher response ratio and a relatively delayed failure as compared to specimen S-1, which may be attributed to the increased  $\rho_w$  of specimen S-2. Despite the increased response ratio, the RC columns again had excessive ductility capacity, and the RC beam of specimen S-2, with  $\rho_w = 0.10$  percent, still requires additional strengthening to allow achieving the overall desired structural displacement ductility capacity.

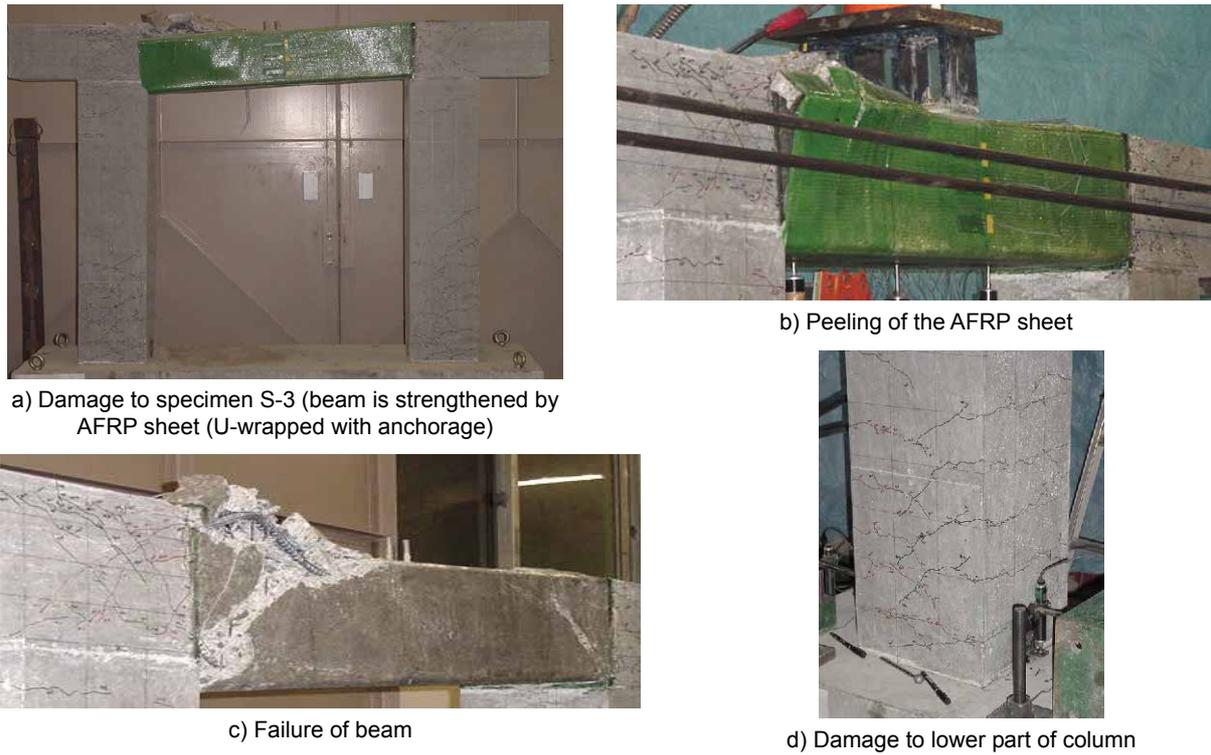
Fig. 9 Damage to specimen S-3 at the end of the experiment (beam is strengthened by anchored U-wrapped AFRP sheets).

the longitudinal bars at the lower plastic hinge of the right column (position A) was observed when the reading of the displacement transducer was equal to  $+3\delta_{y, nominal}$ . Similar to specimen S-1, x-shaped hair cracks appeared in the beam-to-column connections due to reversing the load to the pull direction. Continuing the reversed loading in both the push and pull directions resulted in yielding of the longitudinal bars at the lower plastic hinge of the left column (positions B). Then, yielding of the reinforcing bars of the left plastic hinge (position F) and the right plastic hinge (position E) of the RC beam were recorded. The final failure was of a shear failure mode in the left side of the beam at the second repetition of  $+3\delta_{y, nominal}$ . Similar to the control specimen S-1, no reinforcing bars at the assumed plastic hinges at top of the columns experienced yielding. Fig. 9a shows a picture of the final failure mode of specimen S-3. Fig. 9b shows the peeling of the AFRP sheets,

which occurred at the left part of the RC beam. After conducting the test, the AFRP sheets were detached from the surface of the RC beam in order to view the final shear failure, which occurred in the left side of the RC beam (Fig. 9c). Also shown in Fig. 9c is the x-shaped cracking that was observed at the left beam-to-column connection while Fig. 9d shows the damage, which was observed at the bottom hinge of

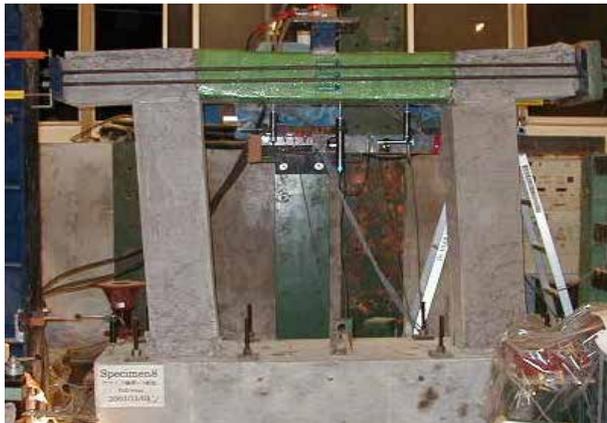
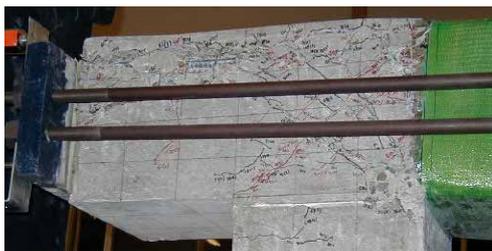
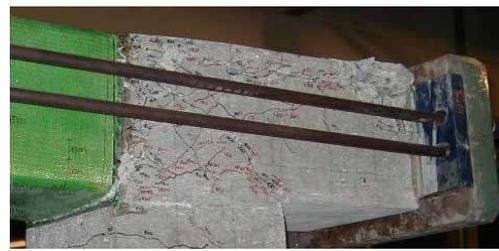
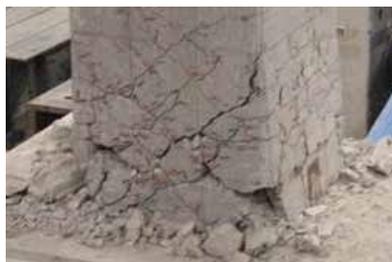
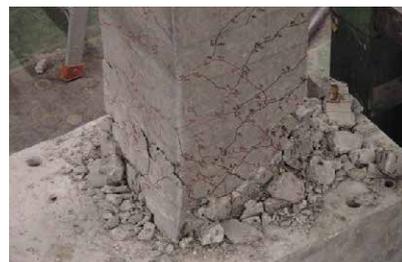
a) Strengthened beam (fully wrapped with AFRP)

c) Left beam-to-column connection

d) Right beam-to-column connection

e) Lower part of left column

f) Lower part of right column

Fig. 12 Damage to specimen S-4 at the end of the experiment (beam is fully wrapped with AFRP sheets).

tion capacity, were recorded and a high response of  $\pm 8.9 \delta_{y,nominal}$  was achieved. No shear failure was observed in any element of the RC frame specimen. No peeling of the AFRP sheets was observed throughout the beam length, and the final failure was of a flexural failure mode, which occurred at the bottom plastic hinges of both columns. The picture in Fig. 12a shows the location of the strain gauges, which were fixed at the surface of the AFRP sheets. Fig. 12b shows a view of the damage that occurred to specimen S-4 at the ultimate displacement. Fig. 12c and Fig. 12d show pictures of the x-shaped cracking at the left and right beam-to-column connections, respectively. Fig. 12e and Fig. 12f show the damage and flexural failure, which occurred at the lower plastic hinges of the left and right columns, respectively.
